# Seismic Response of Pre-Cast Industrial Buildings During 1999 Kocaeli Earthquake

S. Ozden & H. Meydanli

*Kocaeli University, Department of Civil Engineering, Kocaeli, Turkiye*

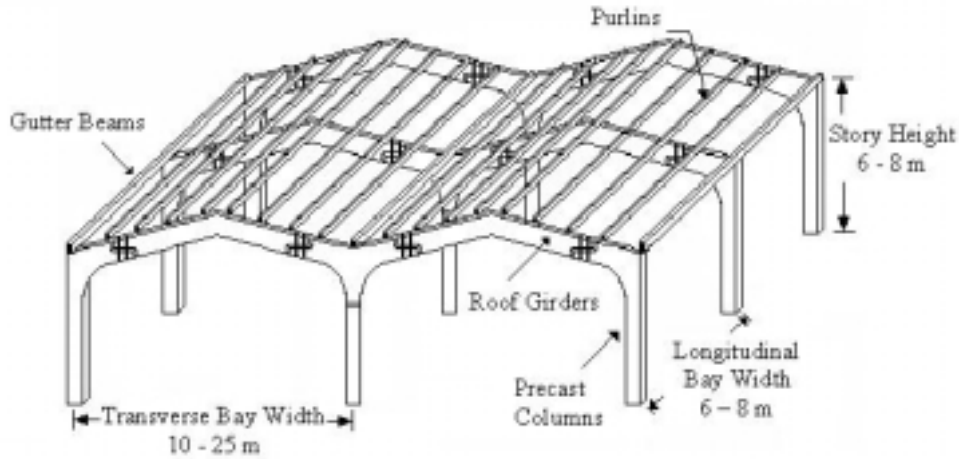
Figure 2. Typical Configuration of Lambda Frame Industrial Buildings.

The connecting members (columns and beams) in the lambda frames were tapered over a certain length, and pinned with one or two bolts passing through both of the members (Figure 2). In the parametric analysis of the sample lambda frame and the selected as-built pre-cast industrial structures with lambda frames, flexural stiffness of the connection region was decreased approximately by %70, with respect to the connecting member stiffness values (Arslan H., 2000). On the other hand, the gutter beam and purlin connections were true pin connections with no moment transfer capability. Roof cover of these industrial buildings was either 3-4 mm cement based corrugated composite sheets or aluminum panels with heat insulation in between.

Field observations on pre-cast lambda frames revealed that most of such buildings underwent large lateral displacements due to small column dimensions, as a result the connections were extremely stressed and the connecting bolts at the beam column connections either slipped through the holes or simply failed under tension. In a certain number of structures, deformed reinforcing bars with cement grouting were used in the connection holes as dowels. In such connections, roof beams were simply fall apart from the connection leading to a total collapse of the roof cover. No diaphragm action, which leads to a force re-distribution among the lateral load carrying system, was observed in the pre-cast lambda frame industrial buildings (Ersoy et.al., 2000).

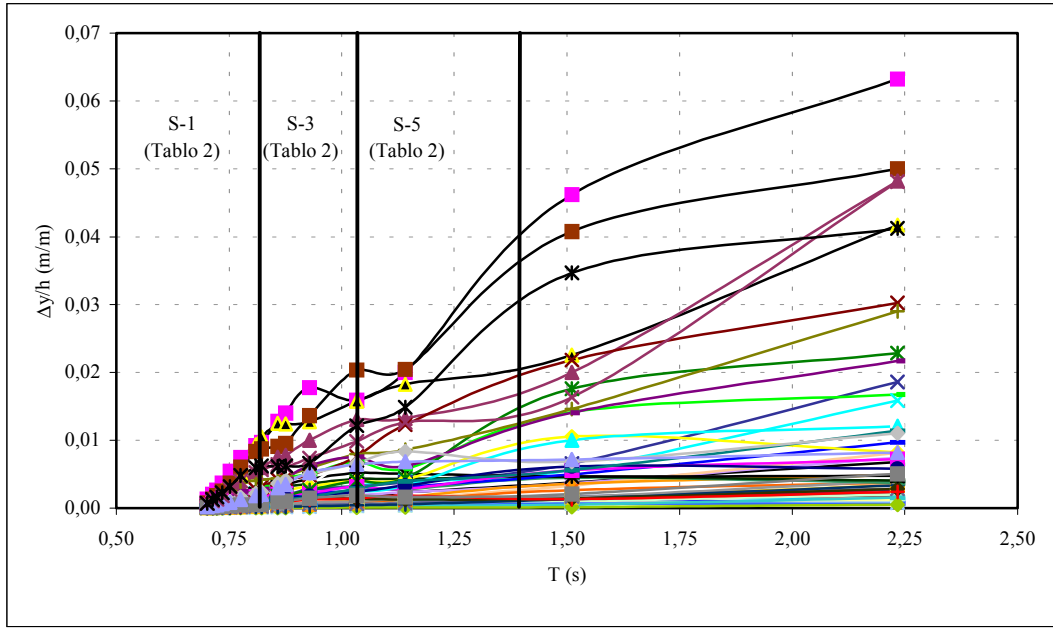
Figure 3. Natural Period versus Lateral Drift in Longitudinal Direction

The maximum drifts in the longitudinal direction for the model Lambda Frames analyzed with 17 different acceleration records are plotted against the fundamental period of vibration of the frame and shown in Figure 3. FEMA-273 drift limits were used for the performance level evaluation of the results. It is observed that the frames with a fundamental period of vibration smaller than 0.7-0.8 sec. may be classified in the immediate occupancy performance level, while it is in collapse prevention performance level in case the natural period ranges between 1.2 and 1.5 sec. Structures with fundamental periods between 0.8 and 1.2 sec. satisfied the life safety performance level.

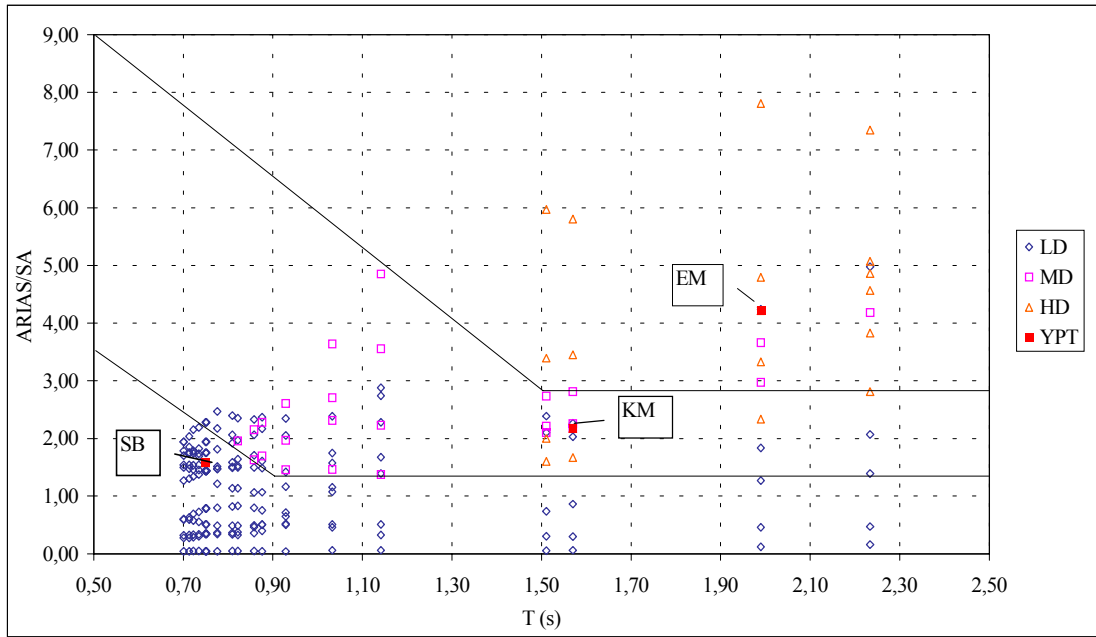
Figure 4. Damage Level Model for Lambda Frame Industrial Structures

As shown in Figure 4, the calculated damage level increases as either the fundamental period of vibration of the Lambda Frame or the (*ARIAS* / *SA*) ratio of the acceleration record increases. Roof drift values, which were used as the indication of the damage level, were smaller for stiff structures no matter which earthquake record was used. It was observed from Figure 4 that points showing the damage levels grouped in three regions, hence boundary limits were drawn accordingly. The buildings EM, KM, and SB were used to calibrate the proposed linear elastic performance model for the pre-cast lambda frame structures. The (*ARIAS* / *SA*) value of the YPT record (Table 1) was used for these buildings. It should be noted that, EM was totally collapsed during the earthquake, while KM had repairable damage and SB was operational right after the event.
