Seismic damages observed in Cultural Heritage Structures after Simav and Van Earthquakes in 2011

E. Akpınar, H.M. Atalay & H. Erdoğan

Kocaeli University, Turkey

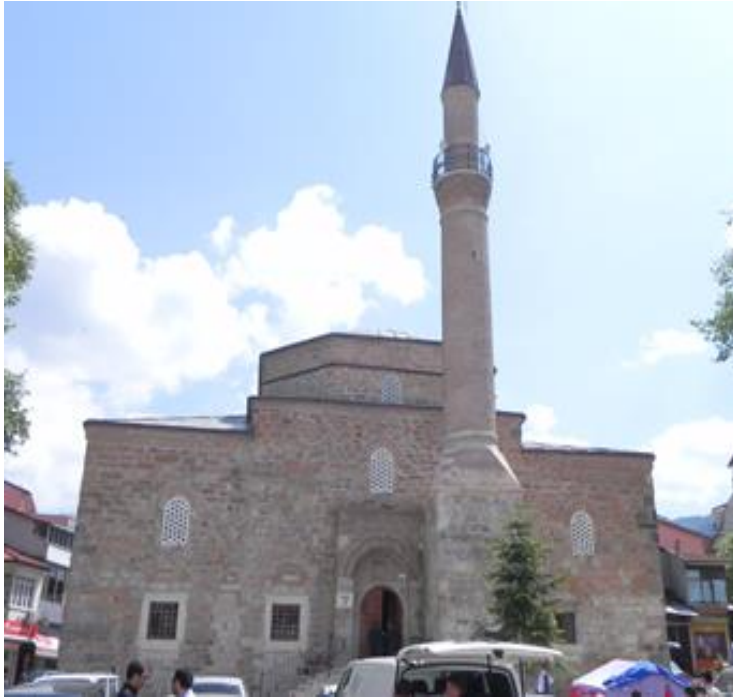
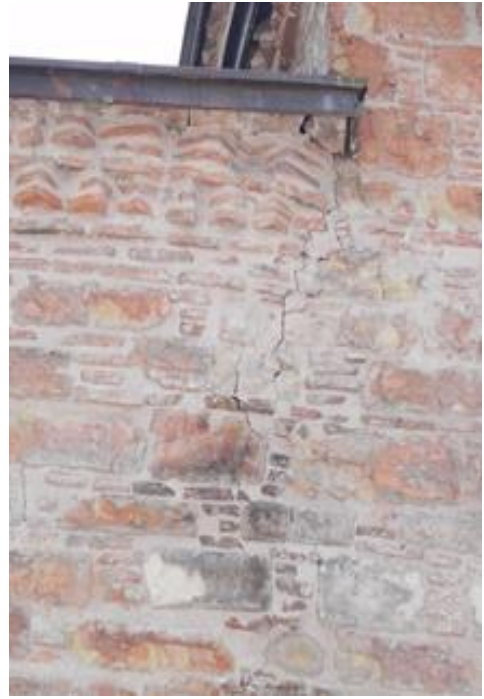
Figure 2. Nasuh Ağa Mosque

Nasuh Aga Mosque, which is located in the downtown of Simav, was made constructed by Nasuh Aga, one of the last seigneurs of Ottoman Empire, in 1789 (Fig.2a). The rectangular-planned mosque has a main dome placed at the center of the structure and two small domes supported by peripherals walls and inner arches at both sides of it. Clay and stone bricks were used to mason the structure while the minaret constructed using only clay tiles.

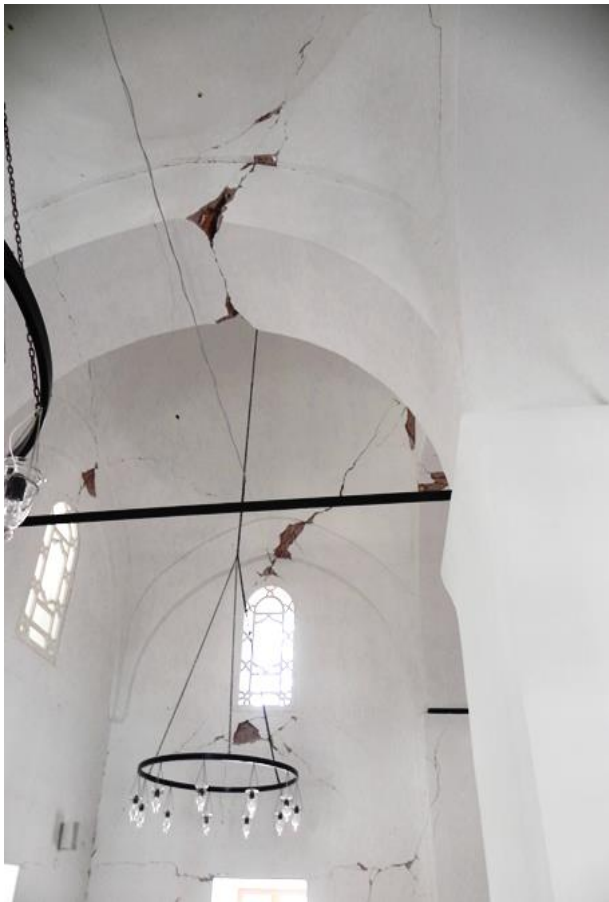
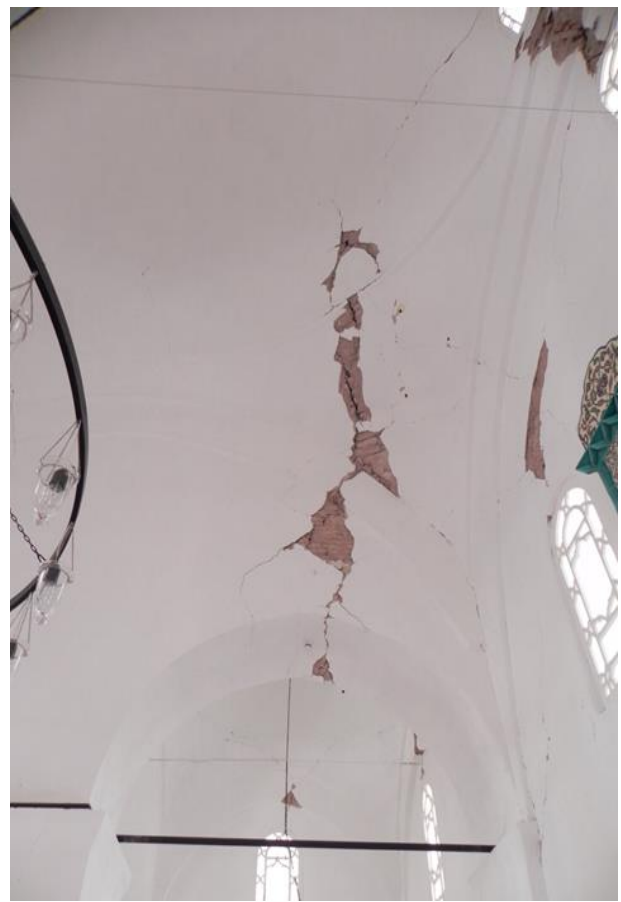
Figure 3. Nasuh Ağa Mosque, arches supporting the main dome

It was seen that the mosque was heavily damaged and almost all arches supporting the main dome have cracks at their crests (Fig. 3). Inner facades of the peripheral walls covered with plaster whereas the outer facades of the walls left as is. It was observed that significant amount of bed joint sliding damage occurred in the walls, which were easily tracked on both plastered and bare facades. Almost all of the cut-stones placed above the windows have cracking and sliding damages.

It was believed that solid masonry walls of which thickness up to 180 cm, pretty thick plaster that implemented in last restoration and symmetrical plan of the structure prevented to total collapse of the structure although heavily damage took in place. The Nasuh Agha Mosque have been decided to shut down for occupancy after the earthquake and retrofitting and strengthening works still in progress today.

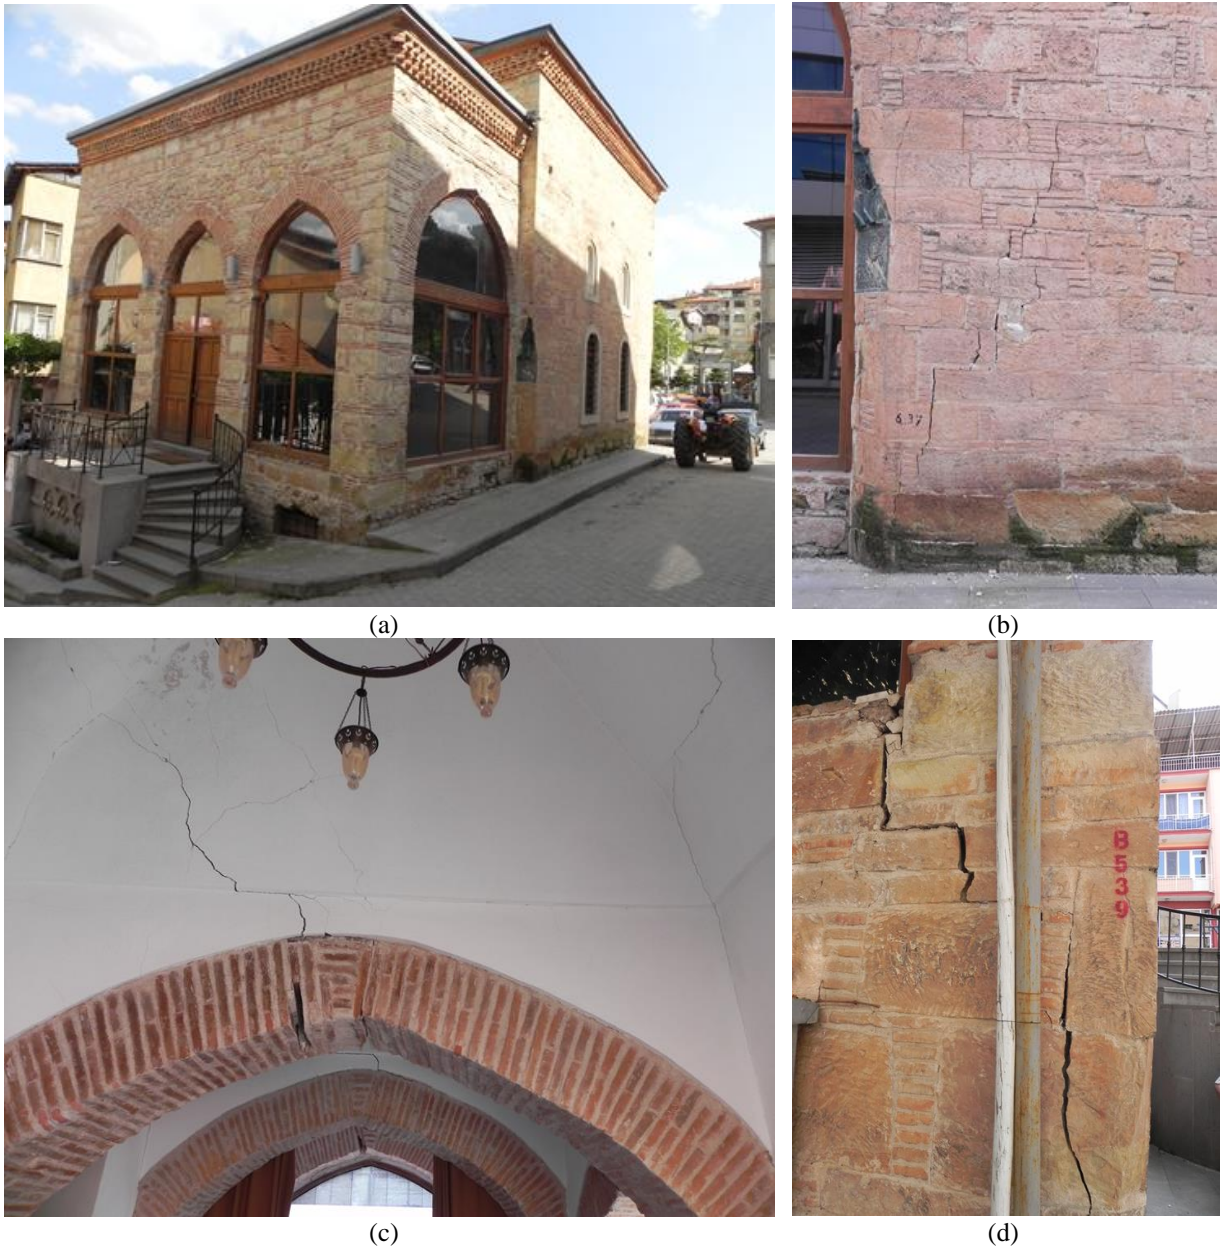
Figure 4. Üzüm Pazarı Mosque

It was observed that the mosque was heavily damaged after the earthquake. Bed joint sliding damage on the peripheral walls was widely taken place in the structure. Especially at the front corner of the semi-basement side, bed joint sliding cracks due to shear action were detrimental as shown in Fig. 4d. Almost all arches covering the late prayers' porch have cracks at their crests spread to the spandrel walls above due to the movement of the pillars (Fig. 4c). It was seen that pivot tiles of some of these arches crushed and dropped down on the floor. Spandrel walls between the window rows have experienced diagonal tension cracks.

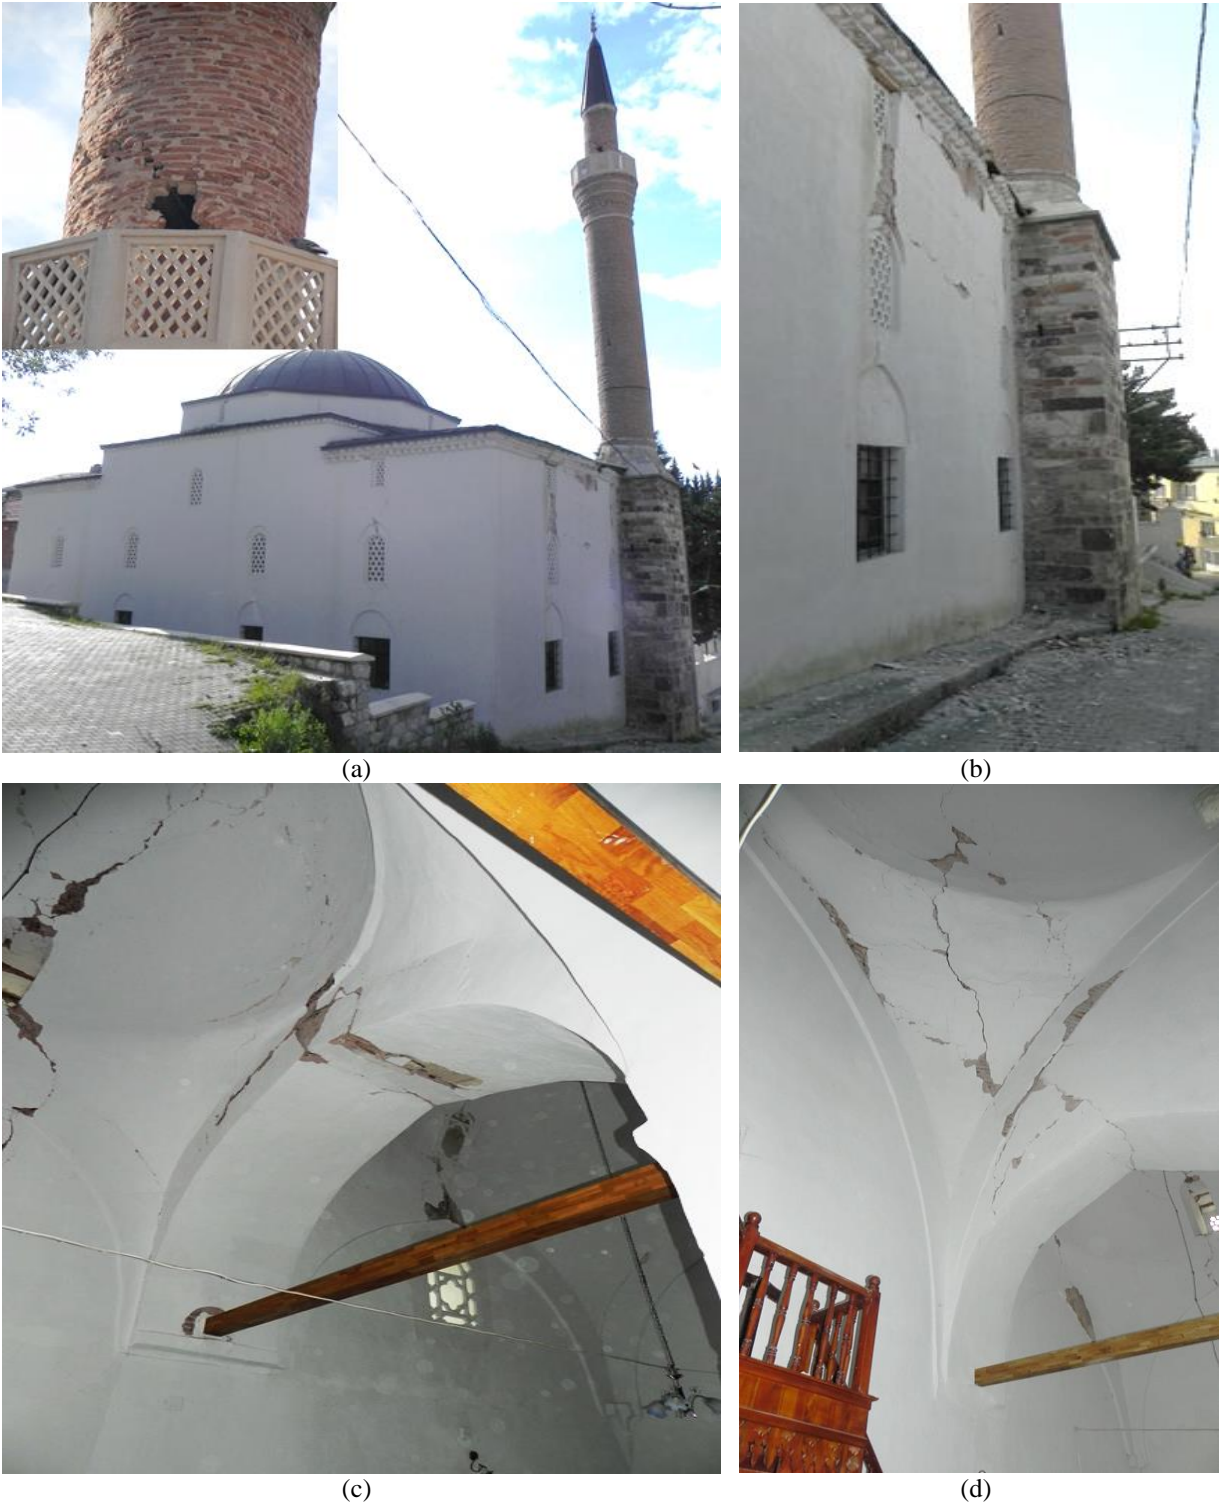
Figure 5. Ulu (Great) Mosque

It was observed that tensile cracks and bed joint sliding cracks took in place in the minaret above the small door opening (Fig. 5a). Top of the sidewalls (the wall next to minaret and opposite one) experienced with partially out of plane movement (Fig 5b). Almost all arches in their crests and pendentif walls (Turkish Triangles) above have tensile cracks (Fig. 5c-d) due to insufficient performance of tension ties. Diagonal tension cracks were seen in the spandrel walls between the window rows.

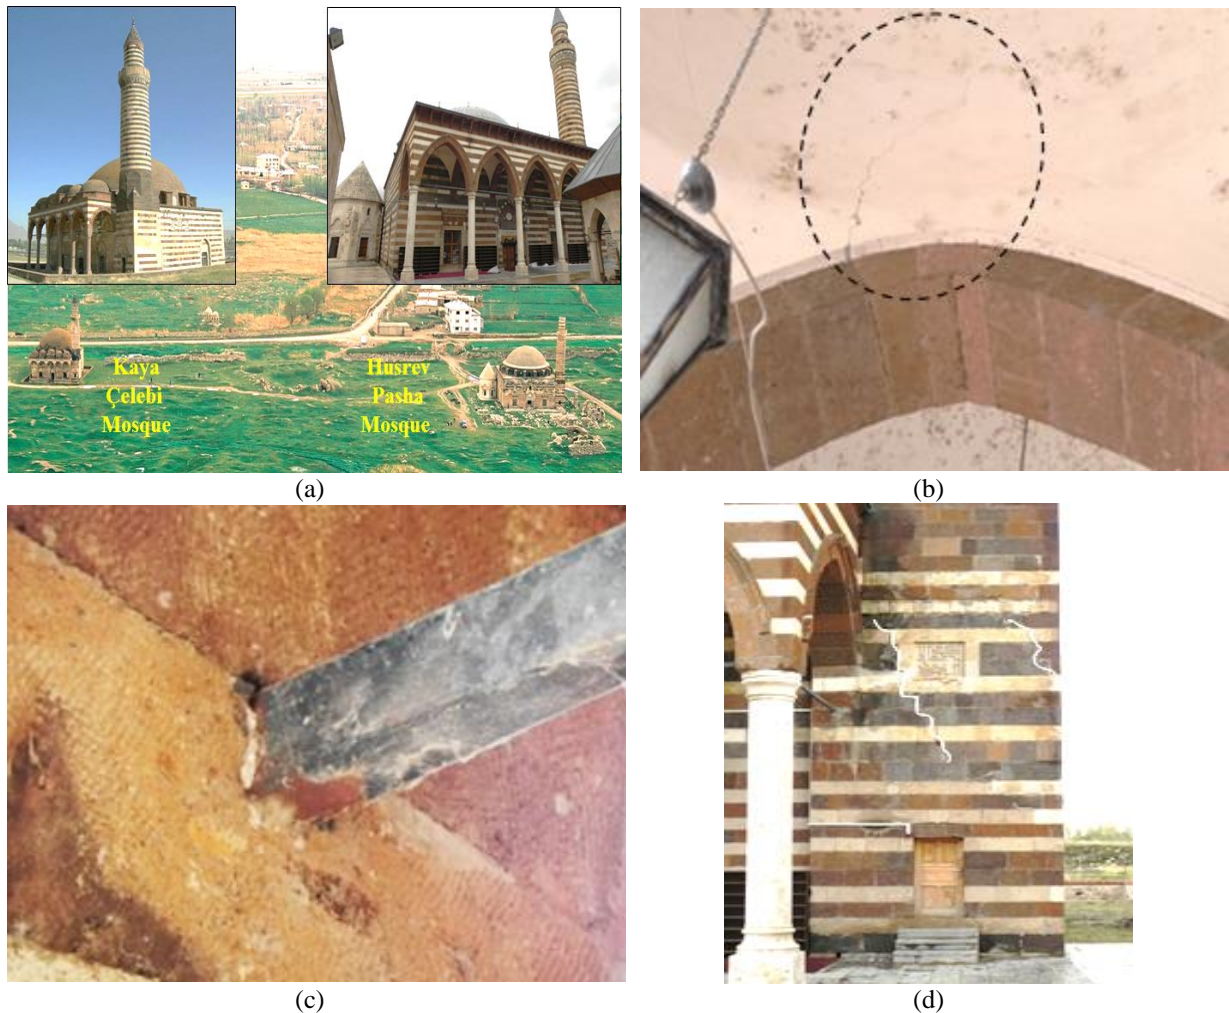
Figure 6. Husrev Pasha Mosque

Tensile cracks were observed in the arch crests (Fig. 6b) spread to the small domes above due to the outward movement of the pillars relative to the peripheral walls. It was believed that such cracking of both the arches and the covering small domes were mainly caused by the insufficient performance of the

tension ties. In fact, the pull-out failure of the tension ties was observed (Fig 6c). Due to the differences in natural frequencies of the minaret and the mosque body, a heavy damage was accumulated on the square pedestal of the minaret, with outward cracks of 45 degrees on both North and South sides (Fig. 6d - north side). Crushing of pedestal wall was also observed on the West facade. The cut-stones just above the entrance door have cracking and sliding on their bed joints.

No damage investigation was allowed inside the structure. Afterwards, it was informed that the late prayers' porch has partially collapsed due to the aftershocks and rest of it and minaret have been demolished to not being hazardous to main body of the mosque. In addition, there was not any remarkable damage in the tomb which was placed next to the mosque.

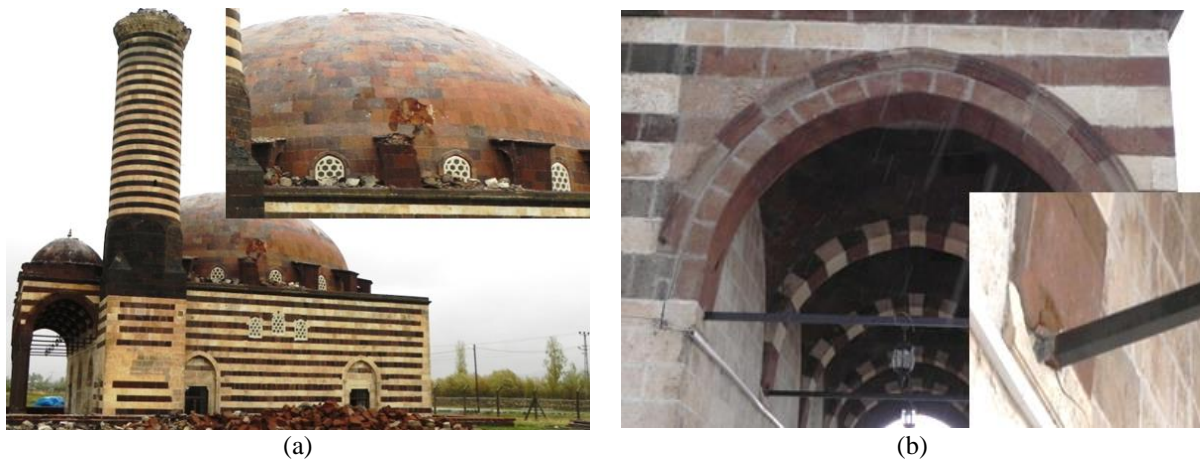
Figure 7. Kaya Chelebi Mosque

Tension ties for the arches covering the late prayers' porch were experienced pull-out type of failure, same as Husrev Pasha Mosque (Fig. 7b). Tension cracks were observed on the arch crests at the late prayers' porch (Fig. 8a) and arches of the windows. Moreover, a very similar shear failure to that of Husrev Pasha Mosque was observed at the pedestal of the minaret (Fig. 8b). However, the stones of the

round part of the minaret also experienced bed joint sliding (Fig. 8b). It was seen that the upper part of the two-colored minaret has toppled (movement was in the East-West direction) and dropped on top of the big dome as well as the semi-arches around the big dome and the nearest small dome covering the late prayers' porch causing crushing and various level of cracking (Fig. 7a).

Thanks to measurement have been taken shortly after the event (supporting the arches covering the late prayers' porch with timber scaffolds), there was no partially or fully collapse due to aftershocks even though the progressed and widened cracks at the late prayers' porch. It was also informed that the minaret was demolished to not being hazardous to main body of the mosque.

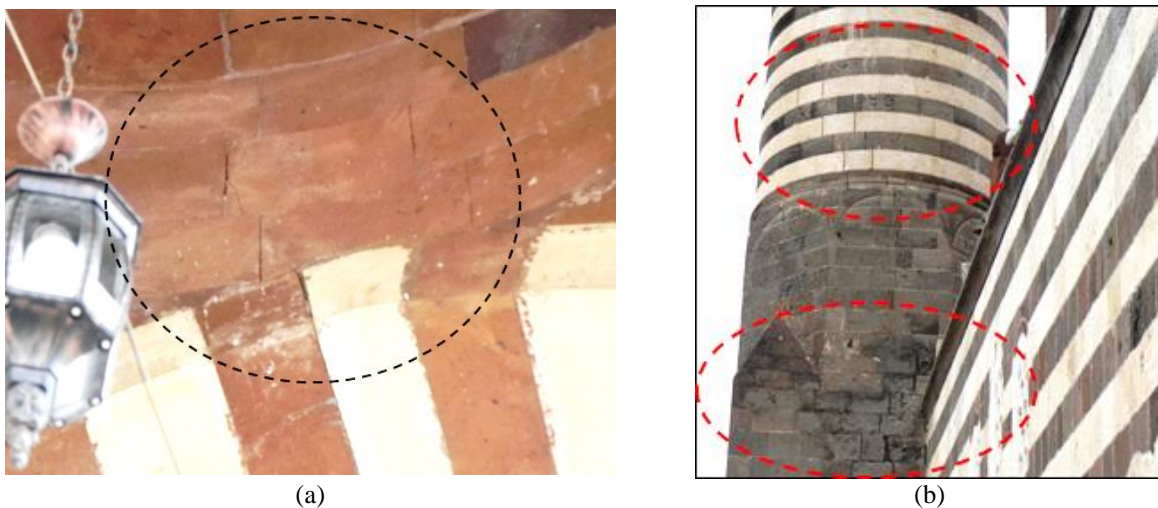
Figure 8. Kaya Chelebi Mosque – further details of damages

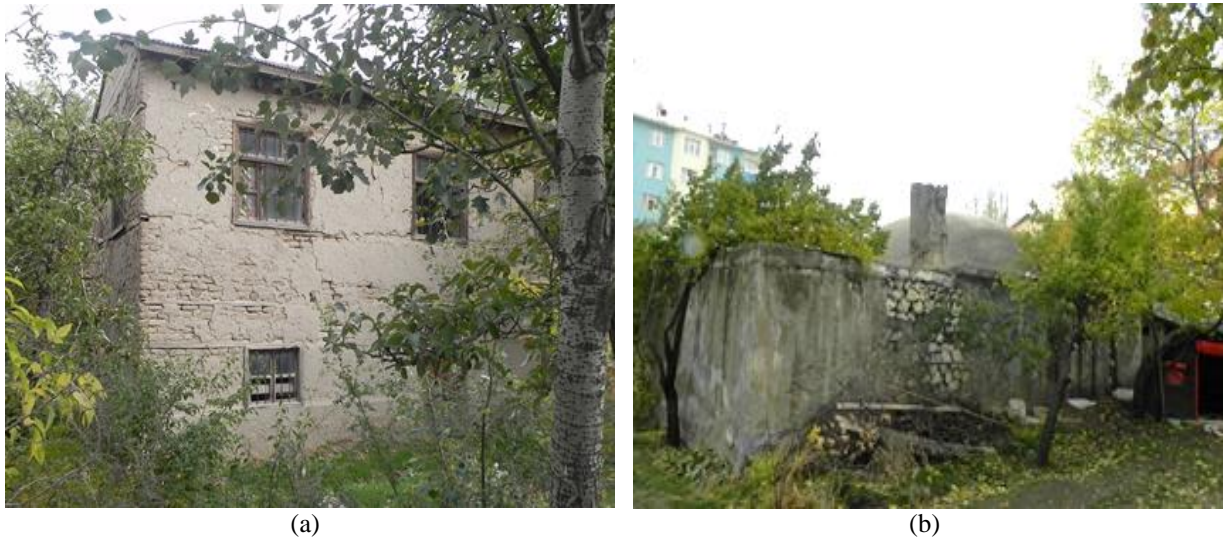
Figure 9. Mud-brick masonry building and the hammam in the same yard

The mud-brick masonry building and the hammam (Turkish Bath) located on the Van Yolu Street, experienced no significant damage at all whereas many buildings were collapsed at the same location (Fig. 9a). It was learned that the building was constructed before the devastating Erzincan Earthquake in 1939.

The superior performance of such a structure may well be attributed to the horizontal timber beams located approximately at every other meters in elevation, if not their continuity at the wall corners. The floors were with logs spanning between the front and back facade wall, resulting one-way load distribution.

Not a definite date was learned for the construction time of the hammam (Fig 9b). The walls and the single dome of the hammam was without significant earthquake damage

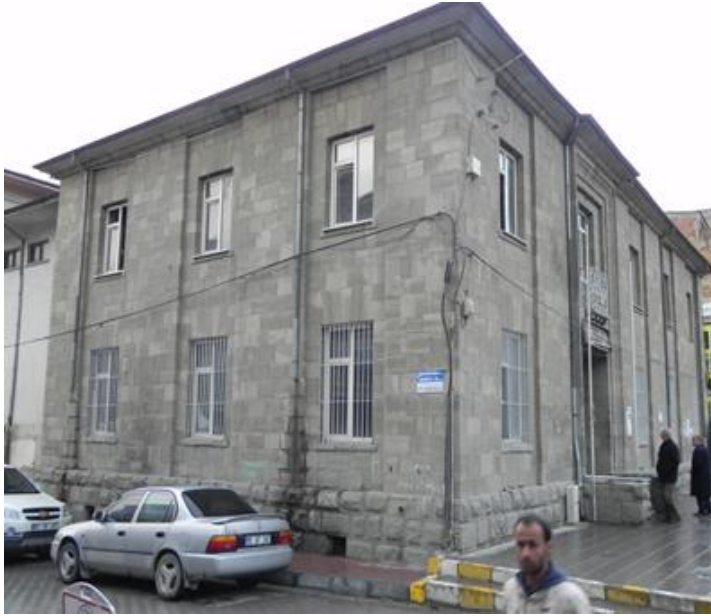
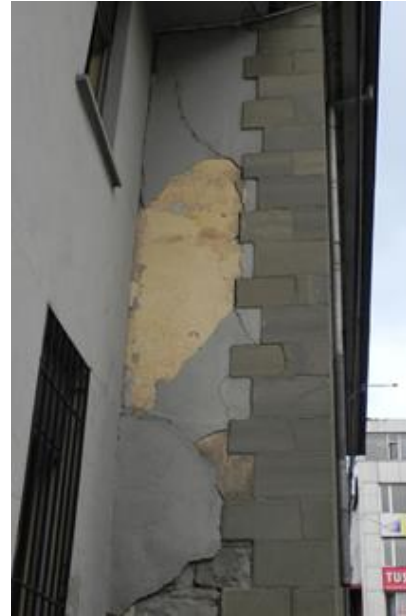
Figure 10. General view of Tekel Building and damage on wall (vertical cracks)

No significant damage was observed in the peripheral walls except the back side wall of the building. Damage investigation on the inside the building could not be possible since the building was not in use during the investigation. The back side of the building has a set-back, resulting a strong-to-weak axis wall connection. Vertical crack was observed on the wall due to the displacement incompatibility (Fig 10b).

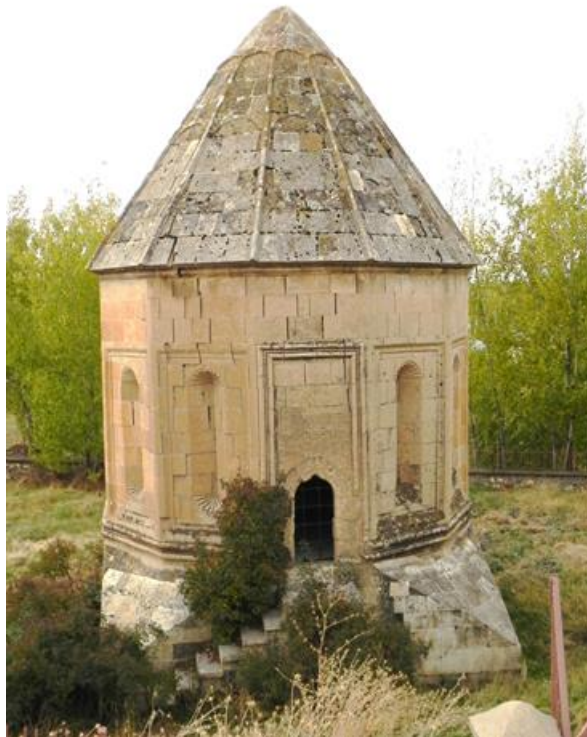
Figure 11. General view of tomb of Kadem Paşa Hatun and bed-sliding damage

No earthquake damage was observed on the tomb's foundation level. On the other hand, the fine-cut stones were experienced bed-sliding damage above the niche level (Fig. 11). It is believed that the successive earthquakes will increase the bed joint sliding between the facade stones, resulting local collapses. The tomb must be retrofitted immediately against future earthquakes.
